# *Orange Beach High-Rise Study*

## **Post-Ivan High-Rise Damage Survey**

High-rise buildings along the Orange Beach, Alabama, Gulf of Mexico shoreline (seaward of Perdido Beach Boulevard.) were inspected by FEMA contractors between November 3 and 18, 2004. The purpose of the inspections was to determine the numbers and elevations of lowest floor living units that were damaged or destroyed by flood effects during Hurricane Ivan. Given the large number of damaged multi-family buildings that would not be classified as substantially damaged, an attempt was made to identify those lowest floor living units that could be repaired or reconstructed in-place, and which would have been classified as substantially damaged had they been individual buildings.

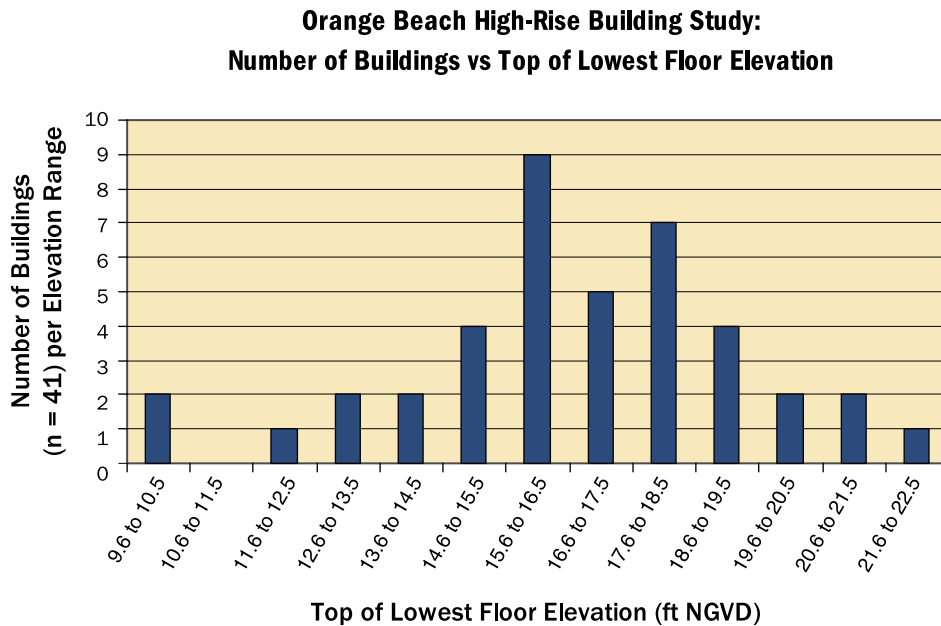
Figure F-3.  
Top of lowest floor  
elevations for Orange  
Beach high-rise buildings

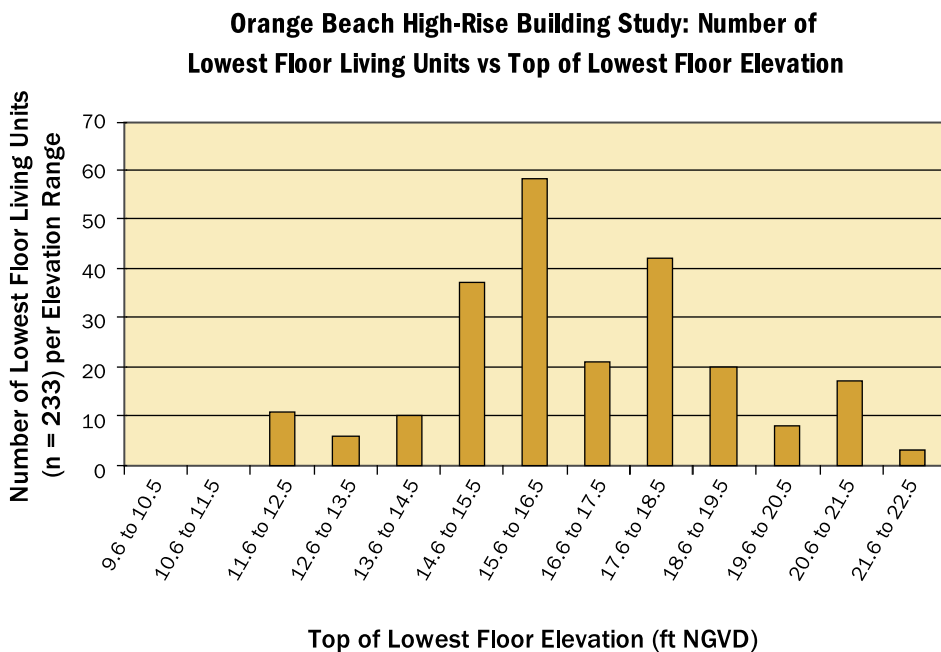
Figure F-4.  
Lowest floor living unit  
elevations

The lowest top-of-lowest-floor elevation was 10 feet the National Geodetic Vertical Datum (NGVD), but the lowest living units were at 12.5 feet NGVD; the highest top of a lowest floor was 21.9 feet NGVD. Approximately two-thirds of the tops of lowest floors and lowest floor living units were between 14.6 feet NGVD and 18.5 feet NGVD.
